KULBIR SINGH, MD, PHD  
University Hospital of North-Norway, Tromsø, Norway

## Fast relief of SVC Syndrome Symptoms with Ultrasound Accelerated Thrombolysis

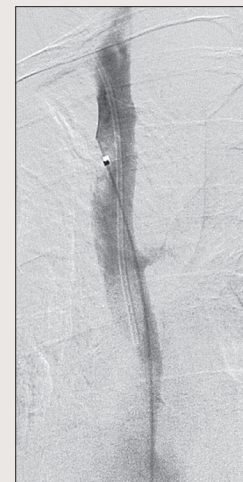
Flow restored in SVC with residual stenosis

- Angiography showed some restoration of flow, with residual stenosis in SVC.
- Subsequent balloon dilation (14 x 40 mm PTA balloon) resulted in excellent flow

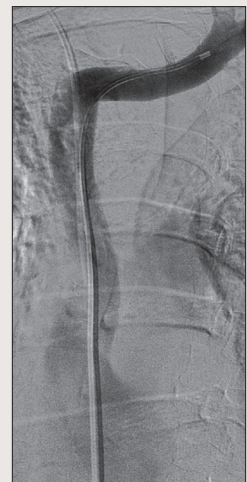
Brisk flow through SVC
